EVALUATION OF EPOXIES TO
PROVIDE STRESS-FREE BONDING
OF PYROCERAM MIRRORS.

PREPARED FOR
NIGHT VISION & ELECTRO-OPTICS
LABORATORY, FT. BELVOIR, VA 22060

CONTRACT No. DAAK70-77-C-0186

11
MAR 1979

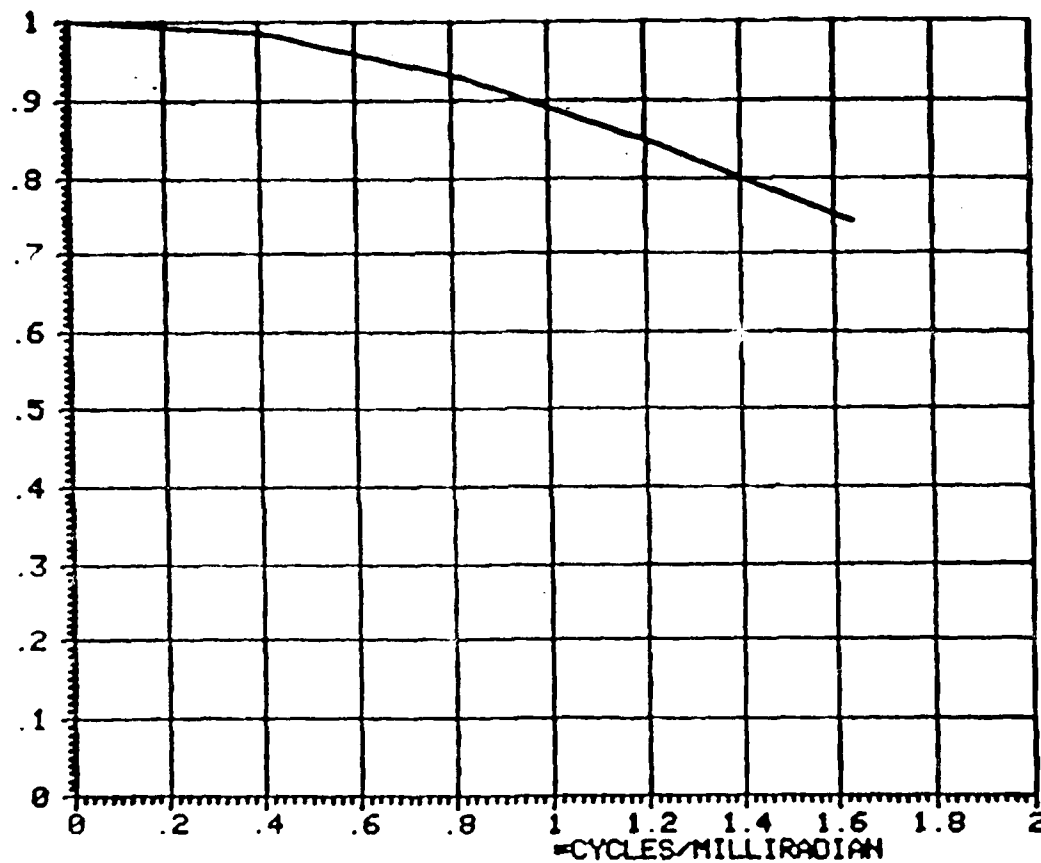
FIGURE 10

Figures 10 and 11 are print outs of the MTF curves achieved for both the Visible and IR sides under dynamic conditions. From this curve, the MTF at .667 cycles/milliradian is 95% or slightly better for both sides. This met the specification. There was an improvement of about 2-3% from the test results obtained previously on this unit (before heat treatment cycling). The static MTF performance of the mirror was also measured.

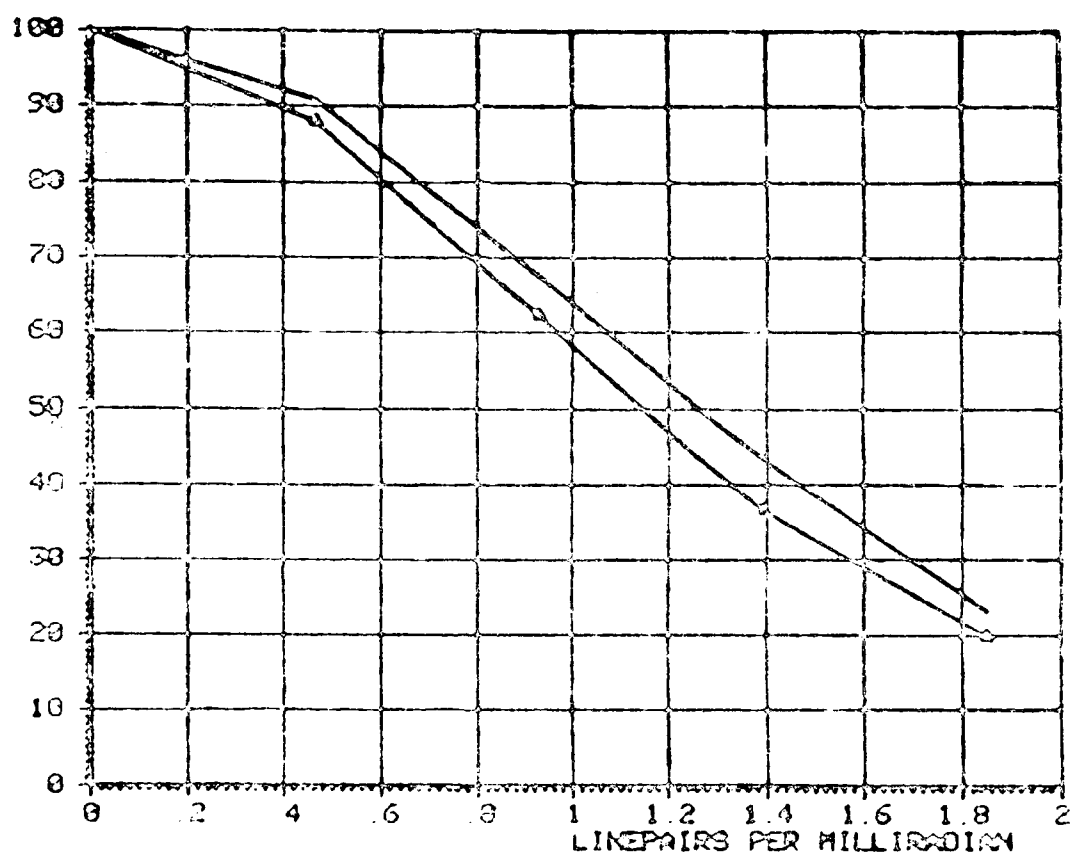
FIGURE 54. MTF RESPONSE, IR SIDE, S/N 009

Figure 54 is a plot of the MTF response achieved and shows a very poor performance. This was to be expected considering the interferogram shown on Figure 53, but the quantitative degradation in MTF could not be predicted.

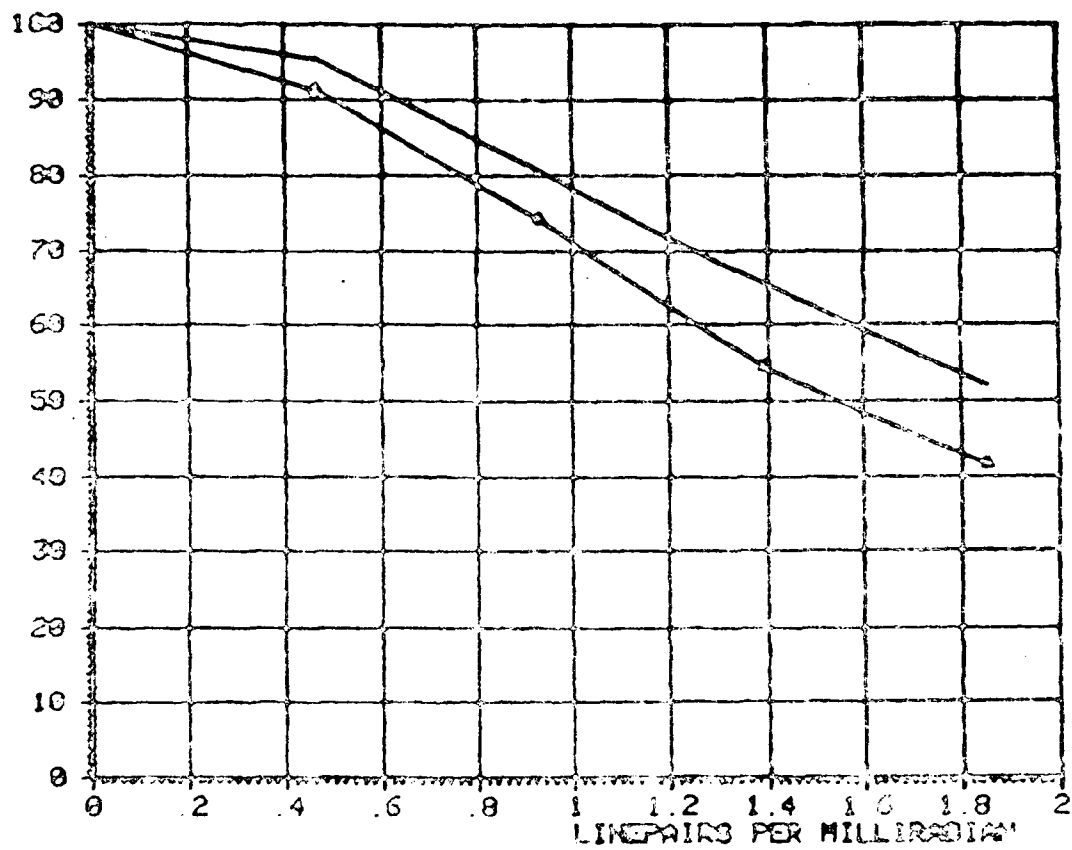
FIGURE 55. MTF RESPONSE, VISIBLE SIDE, S/N 009

Figure 55 is a plot of the MTF response achieved for the Visible side of the same mirror and shows some improvement from the IR side but is still below specification.

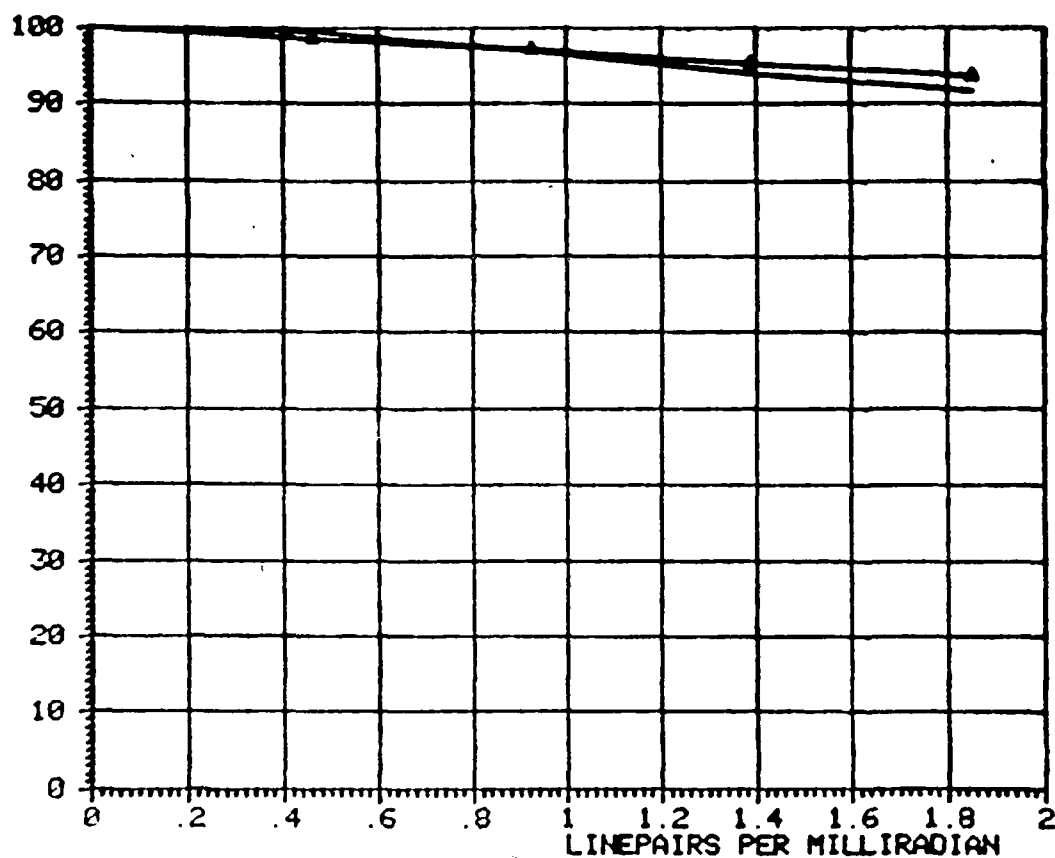
FIGURE 65. MTF RESPONSE, IR SIDE, S/N 009B

The assembly was then placed into a scanner and the scanner was aligned and tested to the ATP. Subsequent to the ATP, the scanner was taken to NVL for both static and dynamic MTF tests. Figure 65 is a plot of the IR side static MTF test results. To say the very least, the same mirror which failed using Stycast has now passed the required MTF limit admirably. Figure 66 is a plot of the Visible side MTF with equally dramatic results.
